# EFFECT OF SHOCK LOADING ON ROCK PROPERTIES AND IN SITU STATES

Terra Tek, Inc.  
420 Wakara Way  
Salt Lake City, Utah 84108

1 June 1980

Topical Report for Period 7 September 1978—1 June 1980

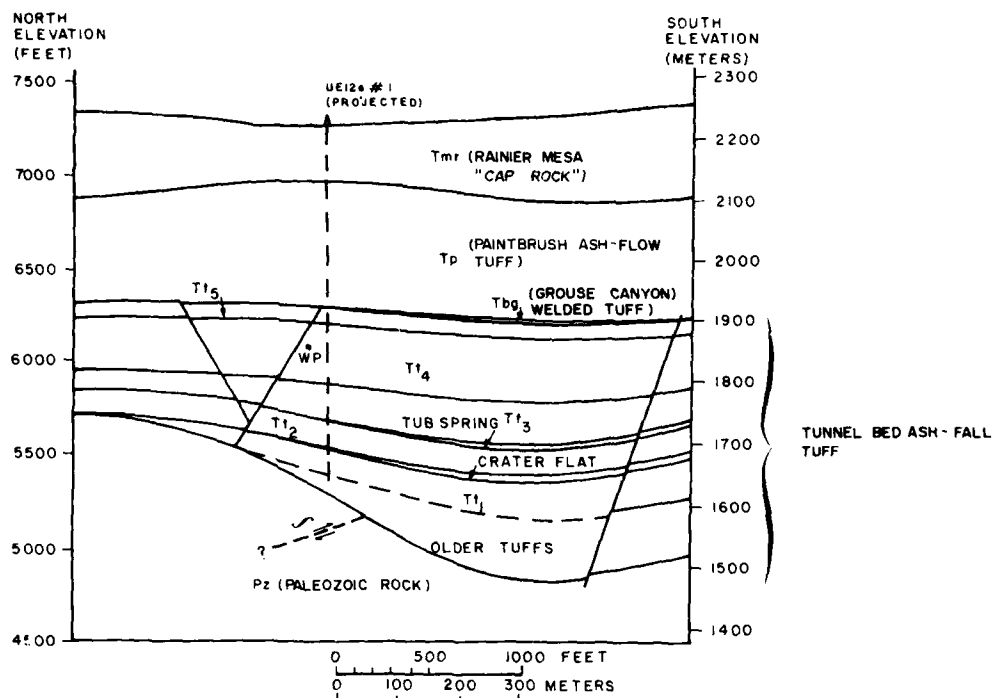
Figure 1a. Approximate north-south cross-section of the Dining Car site.

\* An individual sub-unit within the Tt4 unit shown in Figure 1.

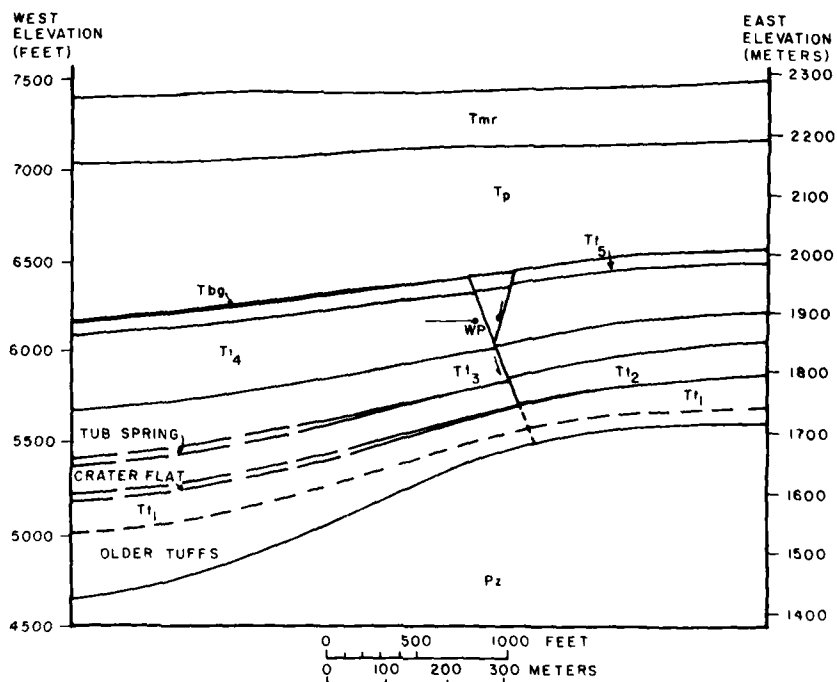
Figure 1b. Approximate west-east cross-section of the Dining Car site.

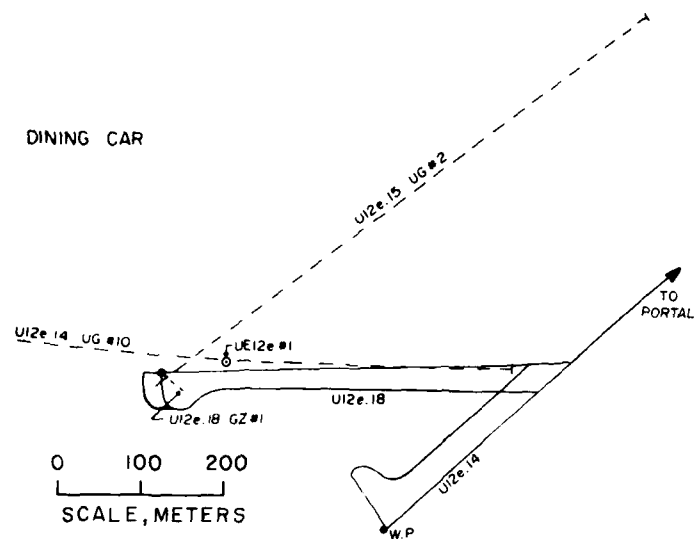
Figure 2. Map showing locations of Dining Car drill holes (plan view).

The Dining Car complex and associated drill holes are shown in Figure 2. Post-Dining Car drifts (re-entry drifts and U12e.20 drifts) and drill holes are shown in Figure 3; dashed lines indicate pre-Dining Car configuration. Figure 4 shows the peak radial stresses due to the Dining Car event.

UE12e#1 (vertical from Mesa top)	}	Pre-Dining Car (see Figure 2)
U12e.14 UG#10		
U12e.15 UG#2		
U12e.18 GZ#1		
U12e.18 DNRE#1	}	Post-Dining Car (see Figure 4)
U12e.20 UG#1, 2, 3		
U12e.20 HF#1, 2, 3, 4, 5, 6, 7, 8, 9, 10A

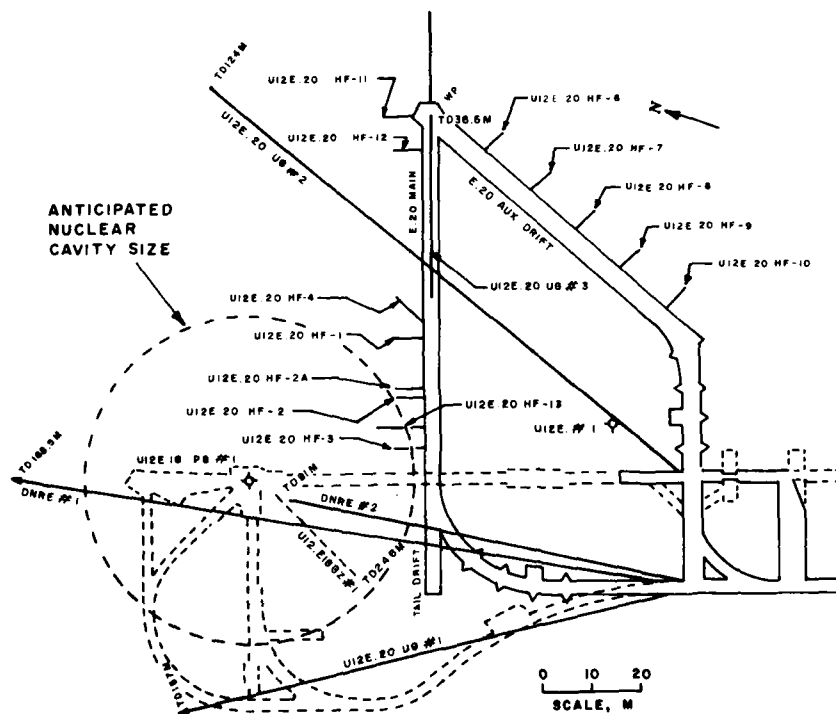
Figure 3. Drill hole locations (post-Dining Car).

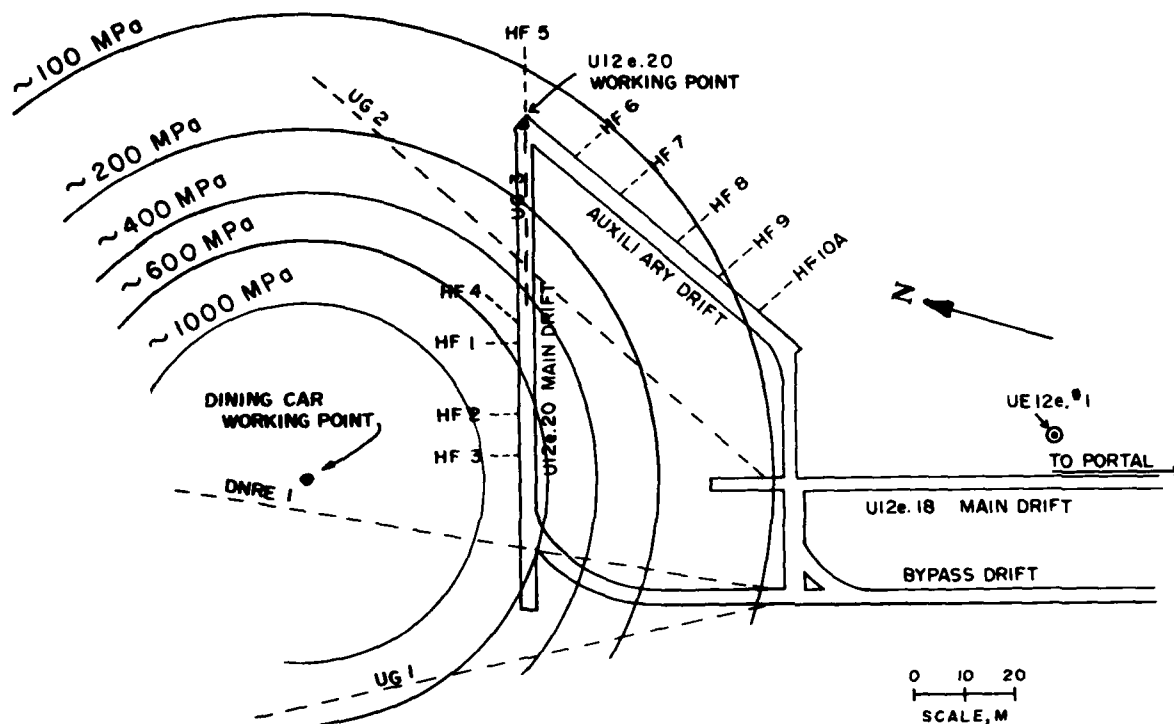
Figure 4. Plan view showing the previous Dining Car location and approximate peak radial stresses, the U12e.20 tunnels, and selected drill holes.

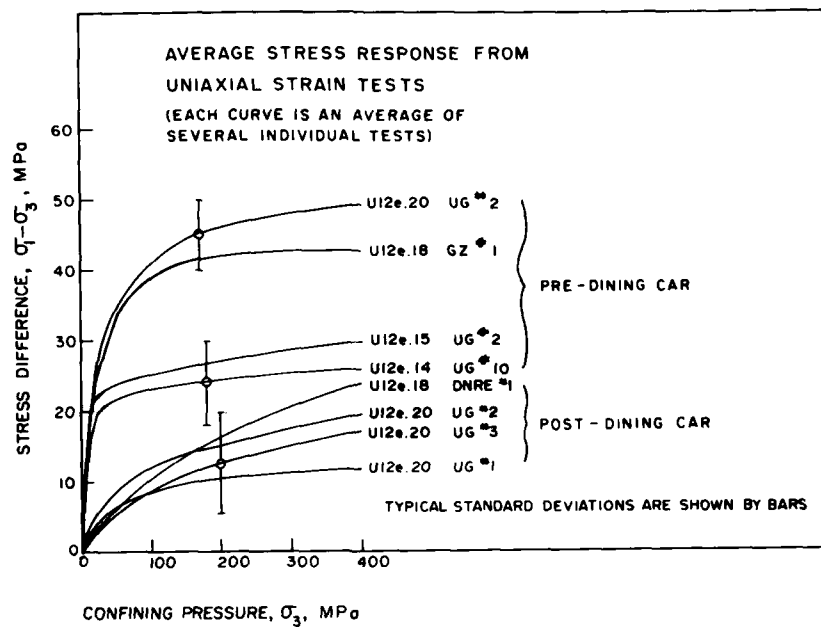
Figure 5. Comparison of preshot and postshot Dining Car uniaxial strain tests -- stress difference versus confining pressure.

*Effects of the Dining Car Event:* Interest in the effects of nuclear shock loading on tuff material led to comparison of preshot and postshot\* Dining Car data. The effects were first observed in a re-entry drill hole and in other site investigation holes from which the uniaxial strain tests produced lower stress differences for given confining pressures\*\*. This lower stress difference becomes immediately apparent when preshot and postshot data are plotted together as shown in Figure 5. Uniaxial strain volume change curves also showed a marked difference between preshot and postshot tuffs. When test results are plotted on an expanded scale, postshot tuffs have a significantly larger "foot" than do preshot tuffs, as shown in Figure 6. Strangely enough, however, the postshot tuffs produced lower uniaxial strain permanent volume compactions than did the preshot (the unloading curves are not shown but the data is listed in Tables A1-A7).

The lower stress-stress response during the uniaxial strain tests, Figure 5, could be a result of both the microcracks and the physical properties changes. Tests have been conducted in which samples were subjected to two cycles of uniaxial strain loading to roughly simulate fractured postshot samples<sup>3</sup>. Many of the samples produced a lower stress-stress curve on the second cycle. There is evidence, therefore, that the existence of microcracks can lessen the shear stress capacity of the material. Likewise, a material with high porosity, high moisture content (i.e. simulating postshot material), and, hence, a lower effective stress, will also exhibit lower shear stresses.

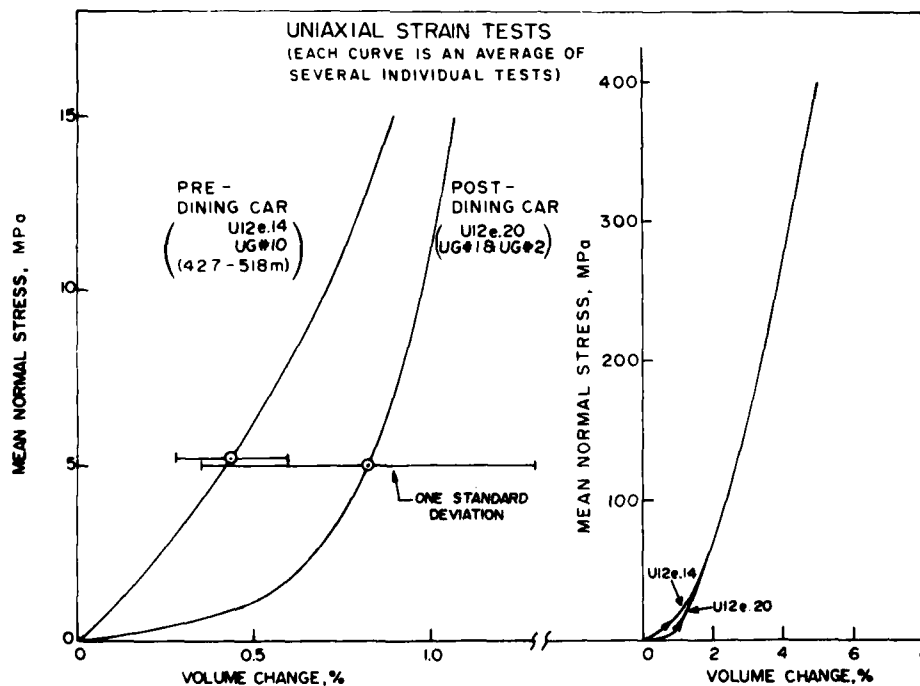
Figure 6. Comparison of preshot and postshot Dining Car uniaxial strain tests -- mean normal stress versus volume change.

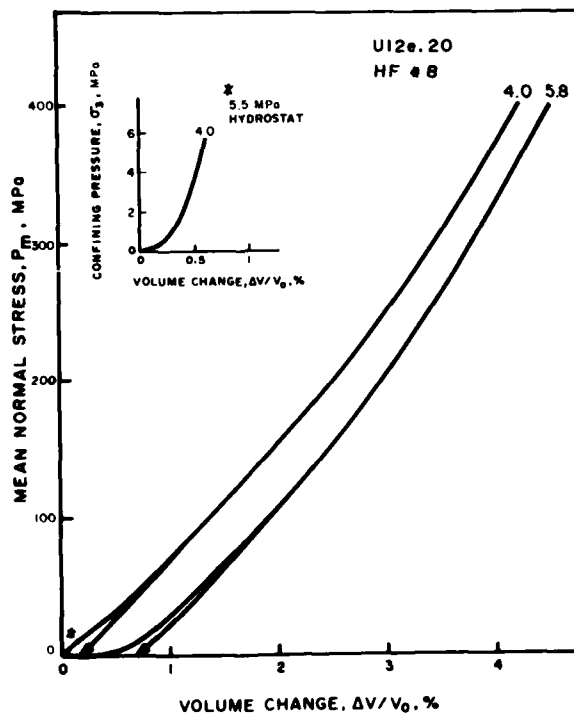
Figure 7. Typical uniaxial strain and hydrostatic compression/uniaxial strain tests on Hybla Gold tuff.

uniaxial strain loading. It was observed that the foot was virtually eliminated and measured permanent compaction from the uniaxial strain portion of the test was reduced substantially (Tables A6 and A7). Typical tests are shown in Figure 7. This observation suggested that microcracks do apparently close when overburden stresses are applied. Similar tests were conducted on a few preshot tuff samples to determine if the initial hydrostatic compression would eliminate any permanent compaction. The data, however, was not sufficient to draw any conclusions. Further tests comparing preshot and postshot tuff are needed to answer these questions of overburden stress and microcrack effect on material properties.

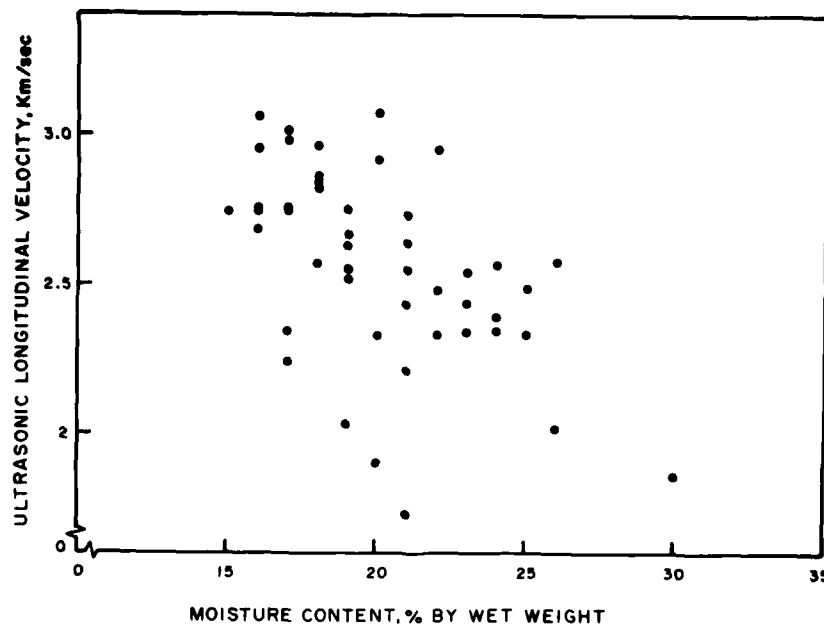
Figure 11. Ultrasonic p-wave velocity versus moisture content for random Area 12 tunnel bed tuffs.

The ultrasonic p- and s-wave velocities conducted at room conditions show several regions of low velocities (not seen pre-Dining Car), see appendix. The decreases were as much as 30 to 50 percent in select areas. This decrease in ultrasonic velocities could also be a result of both the microcracks and the physical properties changes. Test results generated at Terra Tek show ultrasonic longitudinal (p-wave) velocity decreases of up to 25 percent as a result of fracturing by uniaxial compression loading and direct shearing<sup>4</sup>. With regard to the physical properties changes (primarily the increase in porosity and moisture content) Figure 11 shows p-wave plotted versus moisture content for random tunnel bed tuff samples. Although there is considerable scatter, the data does suggest lower p-wave velocities with higher water contents.

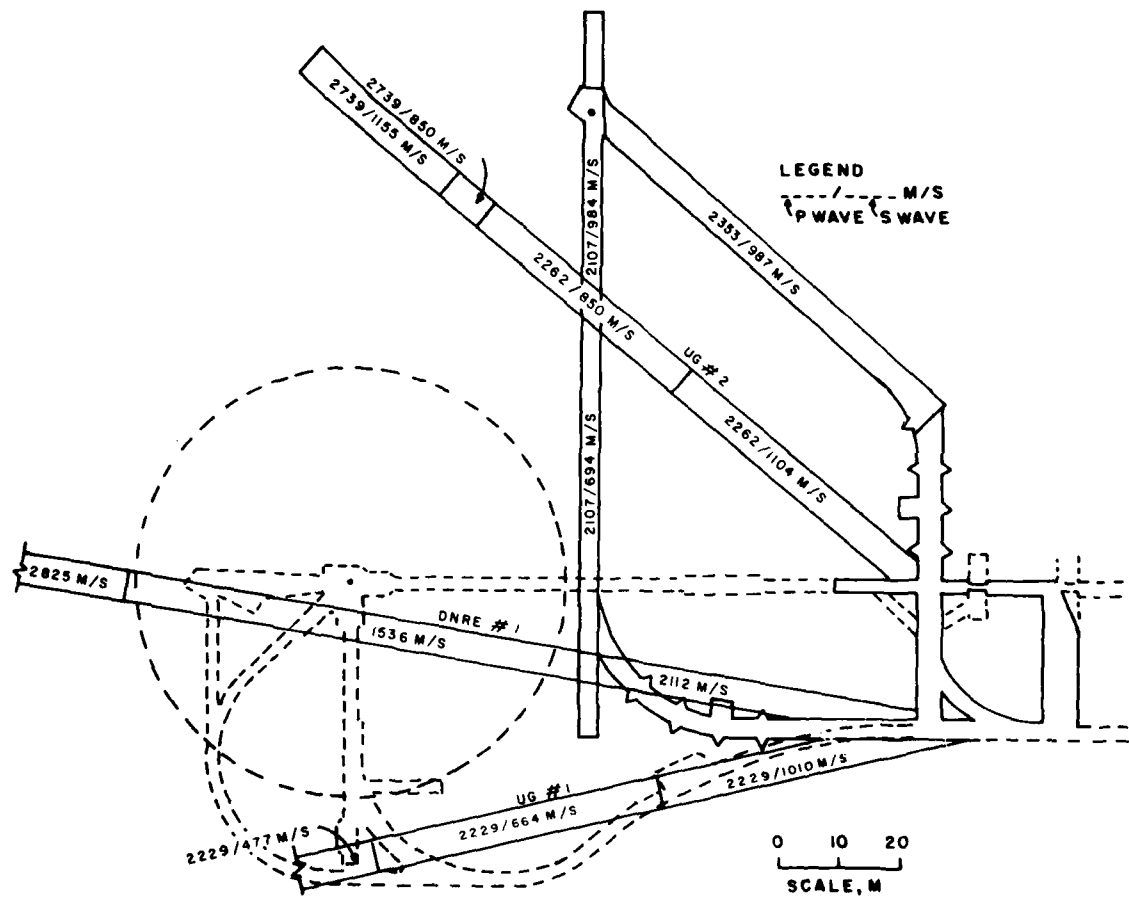
Figure 12. Plan view of the U12e.20 complex showing longitudinal and shear wave velocities.

*Effects of the Dining Car Event:* The seismic velocities measured after the Dining Car event (Figure 12) indicate changes due to the shock loading. Within the "chimney" region (i.e. disjointed) the velocities are, as expected, only about 1500 meters/second (M/S) (the "chimney" region is shown in Figure 3 by the dashed circle around the Dining Car working point). From the "chimney" region out to a radial distance of about 65 meters (i.e. a peak radial stress of about 300 MPa) the velocities ranged from about 2100 M/S to 2200 M/S. The reduction in this region is probably due to the small, tight, discontinuous fractures and faults present as well as possible microfracturing\*. As mentioned in the laboratory test program (Section II), the ultrasonic velocities on core samples from this same region substantiated the decrease in velocity.

At a range of 80 to 90 meters (a radial stress of 100 to 200 MPa), the longitudinal seismic velocities were comparable to the pre-Dining Car values. In this same region, however, shear seismic velocities were still noticeably lower than preshot values. A possible explanation is that the microcracks which exist postshot have a more pronounced affect on the shear wave velocity than on the longitudinal wave velocity.

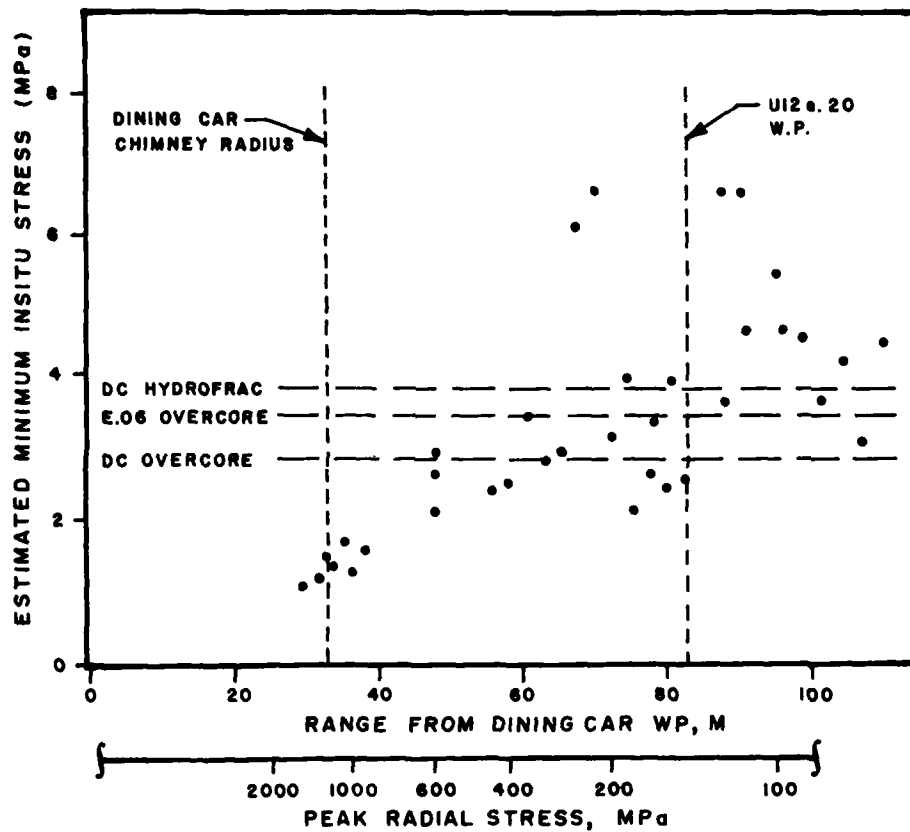
Figure 13. Minimum *in situ* stresses as a function of distance from the Dining Car event and peak radial stresses.

*Effects of the Dining Car Event:* In anticipation of the U12e.20 event (i.e. post-Dining Car), over forty hydraulic fracture tests and several overcore experiments were performed. Figure 13 shows the apparent minimum *in situ* stresses as a function of distance from the Dining Car event and peak radial stress. Near the Dining Car chimney, stresses had decreased to about 1.2 MPa. There appears to be "higher than normal" stresses near the U12e.20 location but further data are necessary to address this phenomena. The results indicate that the Dining Car stress wave did not have an apparent affect on the *in situ* stress field (at least

minimum) at a peak stress less than about 100 MPa (i.e. a range of about 85 meters). However, affects are apparent as the peak stress increases to 1000-2000 MPa.
